## Geotechnical Site Visit Report

Project Name: I-90 East of Hyak Phase 1B	
Contract No: C-7852	Page 1 of 1 Pages
Day: Friday	Date: 9/9/2011

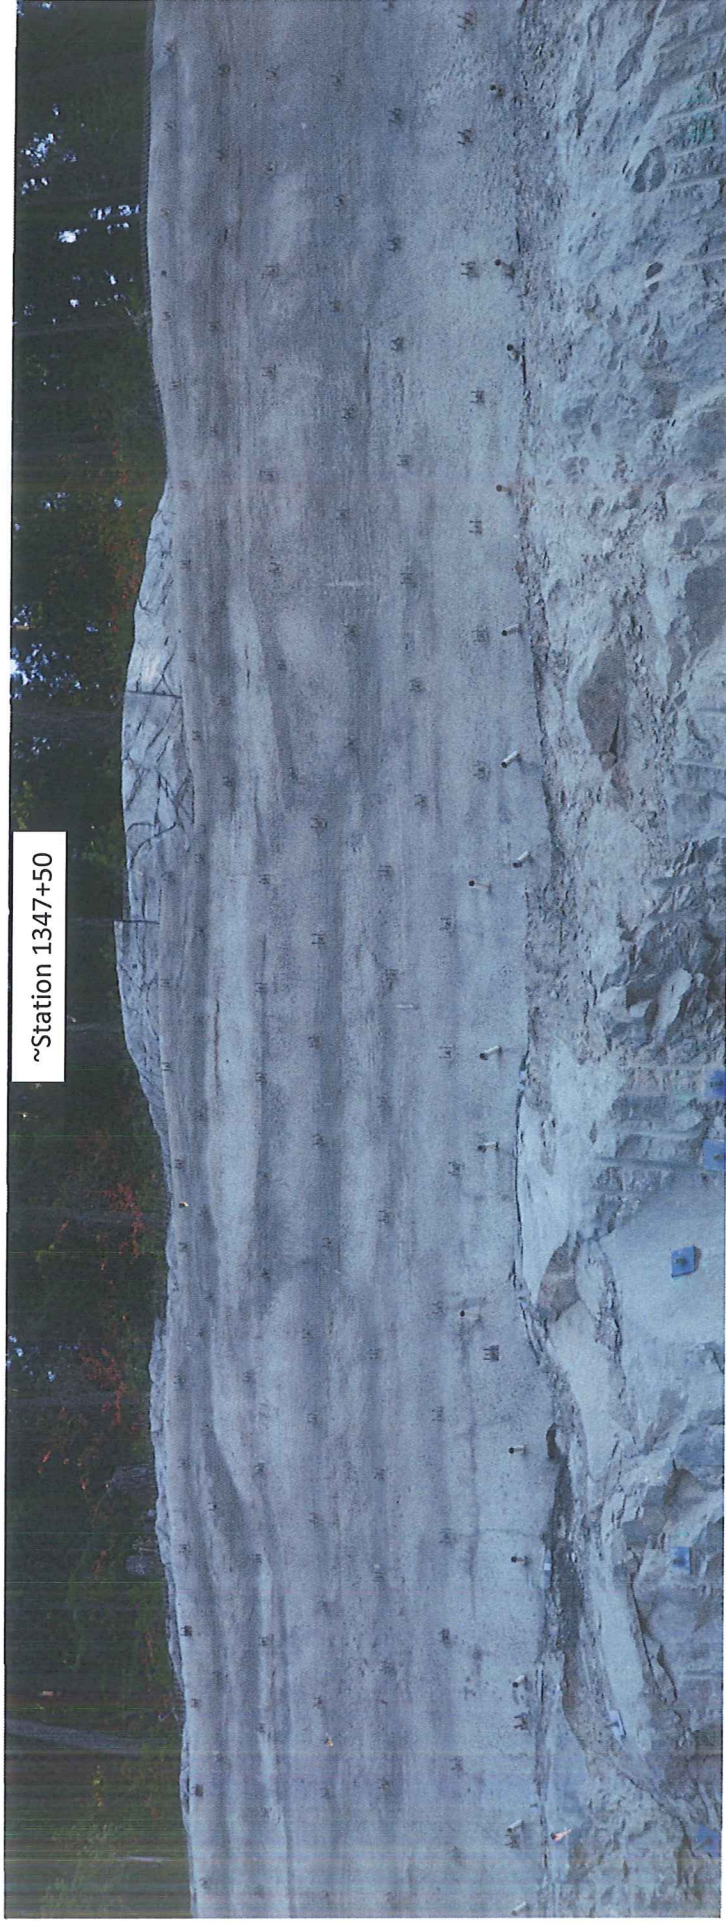
Norm Norrish called around 8:15 am and indicated that the prisms are showing minor movement at the SNW section and requested that I take a look at the shotcrete to determine if there was any cracking in the wall. I drove to the site and the contractor was mucking material from last night's blast, on the east side of the project, beneath the SNW. I inspected the wall and took a series of photographs. From my inspection I could not see any cracking. A few photographs of the wall are shown in Figures 1 and 2.

Figure 1. A photograph showing a portion of the soil nail wall around station 1347+50. No cracking or distress was observed during the inspection.

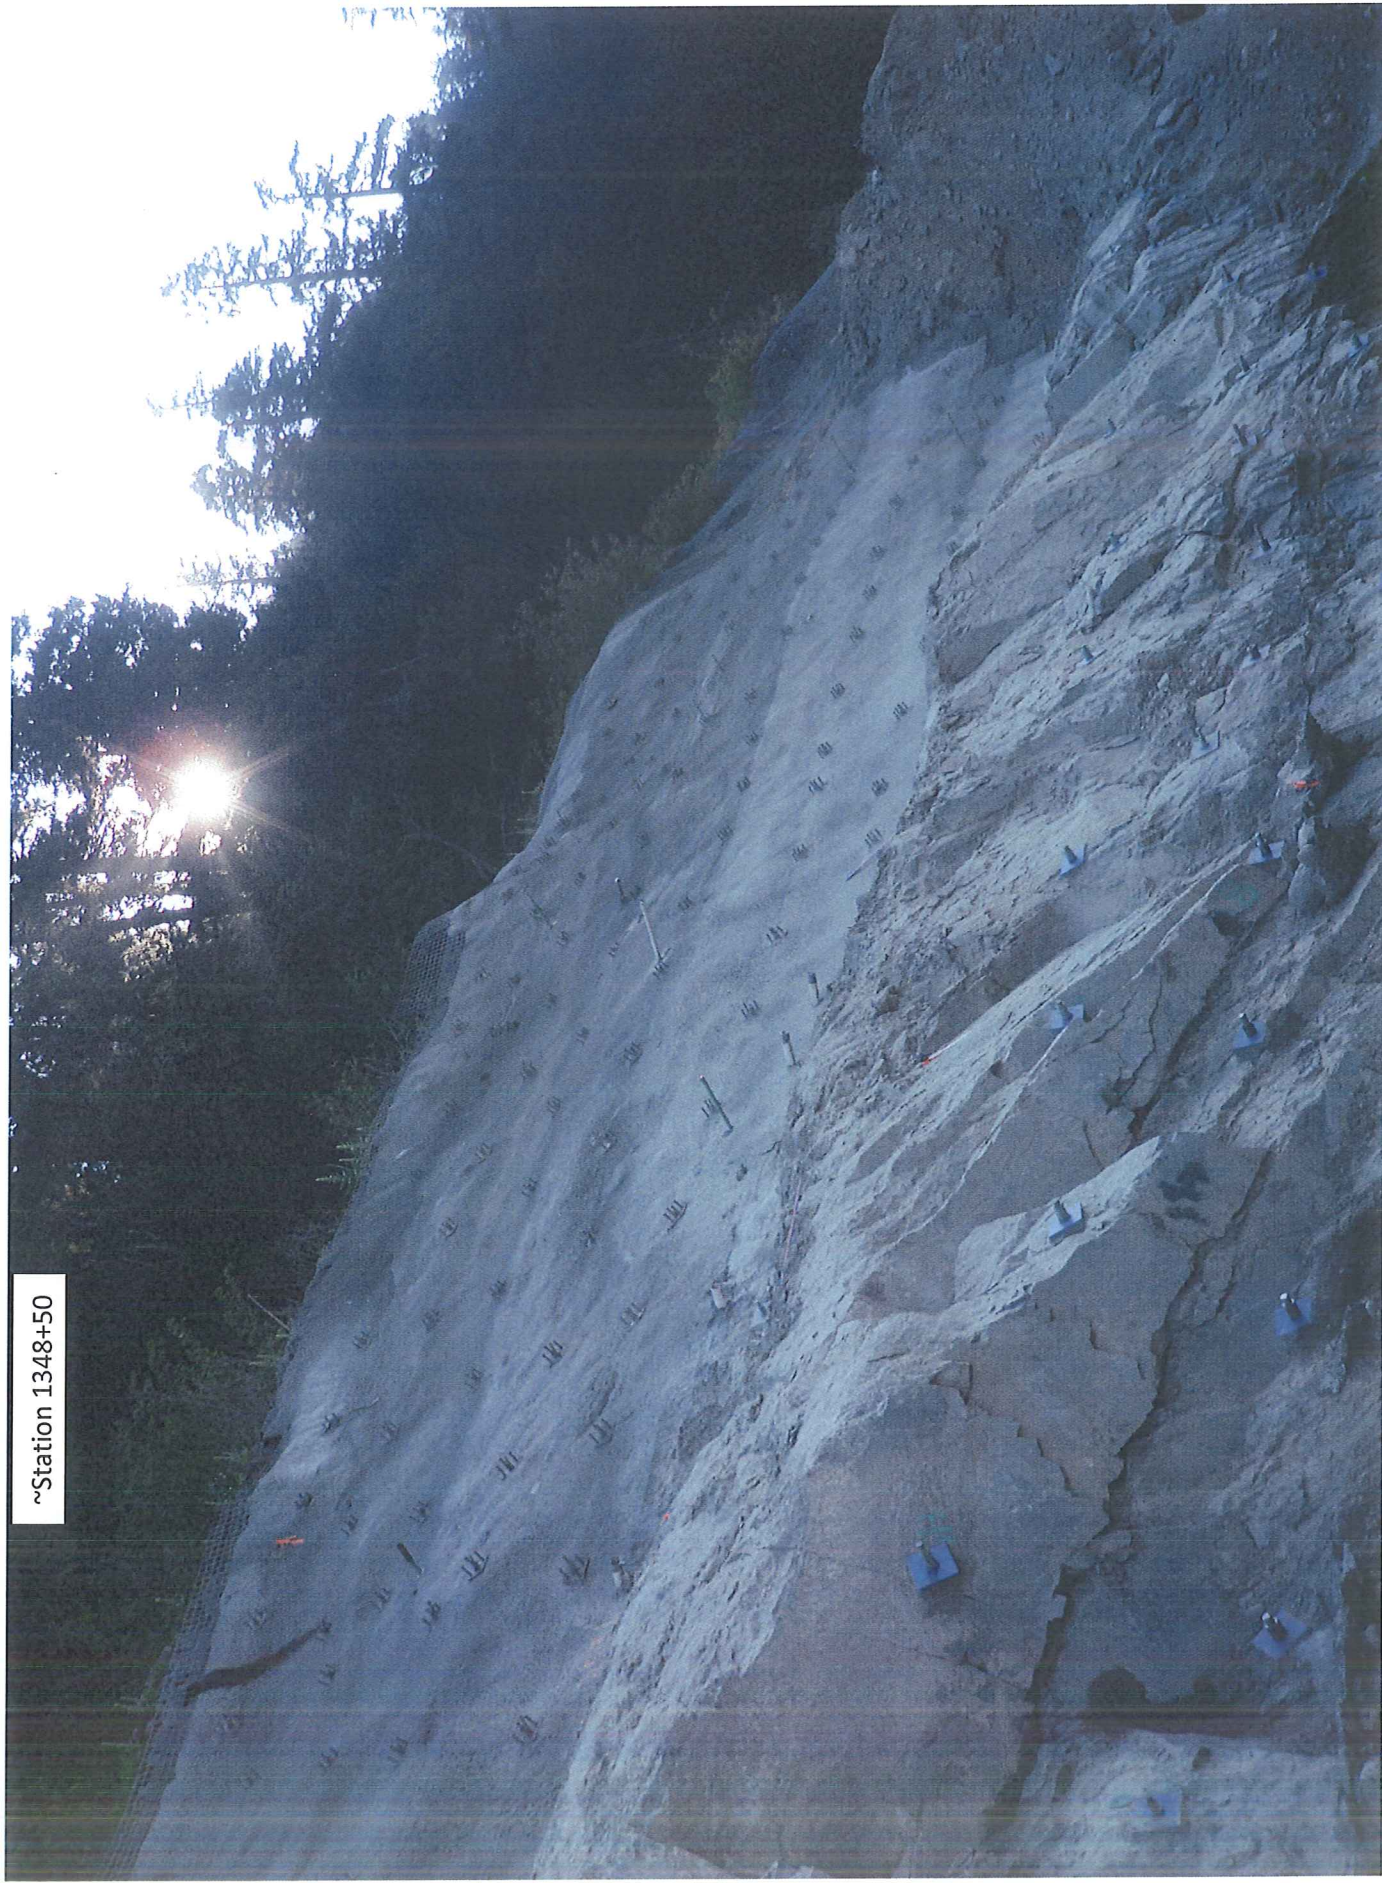
~Station 1348+50

Figure 2. A photograph showing the eastern portion of the soil nail wall around station 1348+50. No cracking or distress was observed during the inspection.
